## TOWN OF RIVER BEND

RE: Manhole Rehabilitation Project

## SANITARY SEWER MANHOLE INTERIOR REHABILITATION SPECIFICATIONS

## MACP Inspection Report

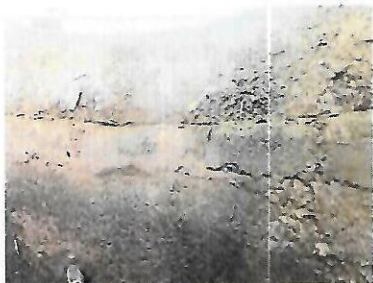
Distance 0.7 MHI Component: Chimney Interior

MACP Code: Mortar Missing Small

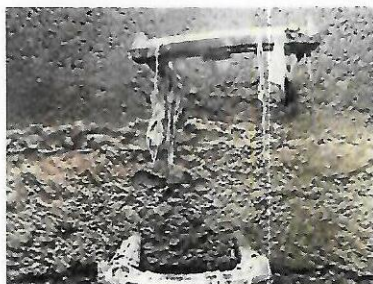
Distance 2.9 MHI Component: Wall Interior

MACP Code: Deposits Attached Ragging

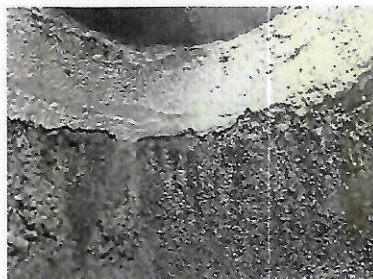
Distance 4.5 MHI Component: Wall Interior

MACP Code: Mortar Missing Medium

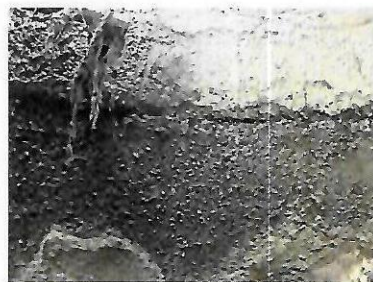
Distance 5.8 MHI Component: Wall Interior

MACP Code: Infil Stain

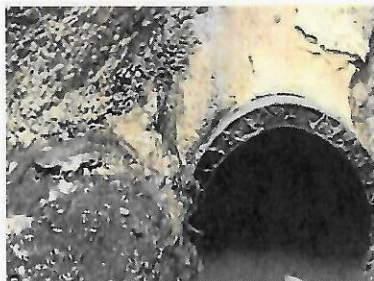
Distance 6.3      MH Component: Bench      MACP Code: Infil Weeper      Continuous:  
1st Dimension:      2nd Dimension:      Percent:      At/From: 11      To:      ☐ Joint      ☐ Step  
Remarks:

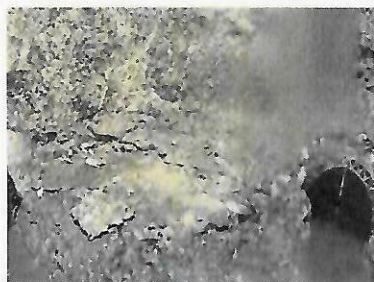
Distance 6.4      MH Component: Bench      MACP Code: Deposits Settled Compacted      Continuous:  
1st Dimension:      2nd Dimension:      Percent: 5      At/From: 11      To: 3      ☐ Joint      ☐ Step  
Remarks:

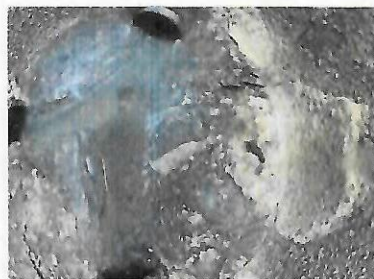
Distance 6.5      MH Component: Bench      MACP Code: Deposits Settled Fine      Continuous:  
1st Dimension:      2nd Dimension:      Percent: 5      At/From: 6      To: 10      ☐ Joint      ☐ Step  
Remarks:

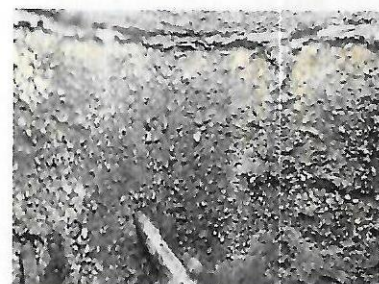
Distance 0.8    MH Component: Chimney Interior    MACP Code: Infil Stain    Continuous: ☐ Joint ☐ Step  
 1st Dimension:    2nd Dimension:    Percent:    At/From: 7    To: 8

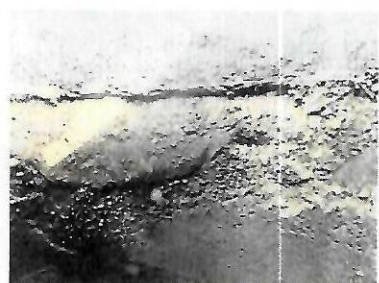
Distance 0.8    MH Component: Chimney Interior    MACP Code: Mortar Missing Medium    Continuous: ☐ Joint ☐ Step  
 1st Dimension:    2nd Dimension:    Percent:    At/From: 6    To: 6

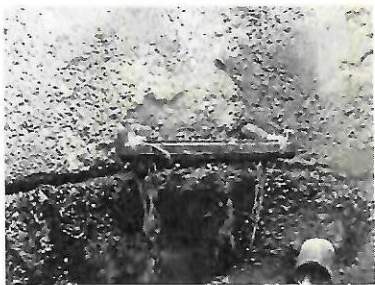
Distance 3.1 MH Component: Wall Interior MACP Code: Deposits Attached Ragging Continuous:  
 1st Dimension: 2nd Dimension: Percent: 5 At/From: 6 To: 7 ☐ Joint ☒ Step  
 Remarks:

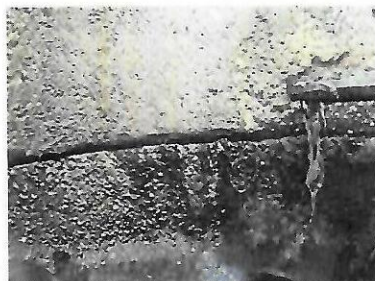
Distance 3.5 MH Component: Wall Interior MACP Code: Infil Stain Continuous:  
 1st Dimension: 2nd Dimension: Percent: At/From: 3 To: 8 ☒ Joint ☐ Step  
 Remarks:

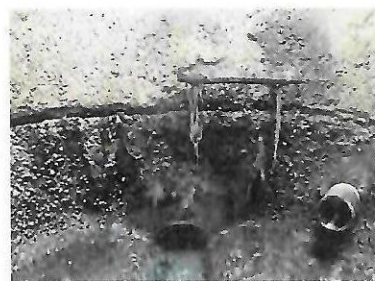
Distance 3.5 MH Component: Wall Interior MACP Code: Mortar Missing Large Continuous:  
 1st Dimension: 2nd Dimension: Percent: At/From: 11 To: 8 ☐ Joint ☐ Step  
 Remarks:

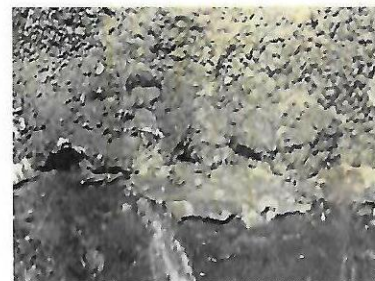
Distance 5 MH Component: Bench MACP Code: Deposits Settled Compacted Continuous:  
 1st Dimension: 2nd Dimension: Percent: 5 At/From: 11 To: 1 ☐ Joint ☐ Step  
 Remarks:

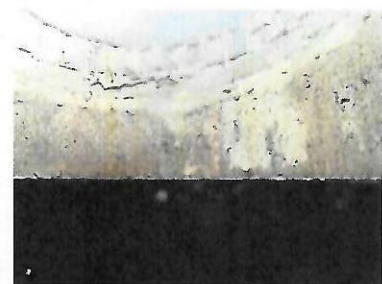
Distance 1.4 MH Component: Chimney Interior MACP Code: Infil Stain Continuous:  
 1st Dimension: 2nd Dimension: Percent: At/From: 12 To: 1 ☐ Joint ☐ Step  
 Remarks:

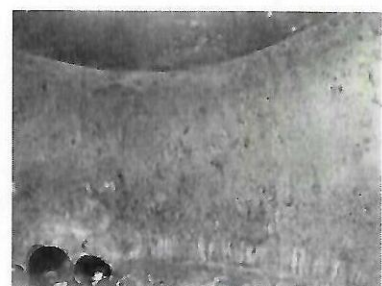
Distance 1.9 MH Component: Wall Interior MACP Code: Infil Stain Continuous:  
 1st Dimension: 2nd Dimension: Percent: At/From: 2 To: ☐ Joint ☐ Step  
 Remarks:

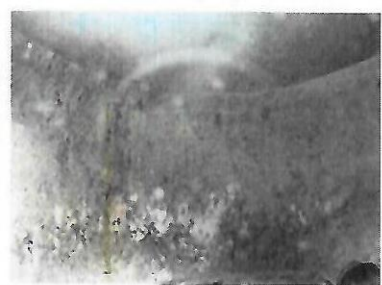
Distance 1.9 MH Component: Wall Interior MACP Code: Infil Stain Continuous:  
 1st Dimension: 2nd Dimension: Percent: At/From: 9 To: ☐ Joint ☐ Step  
 Remarks:

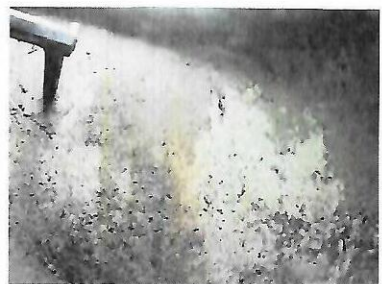
Distance 1.9 MH Component: Wall Interior MACP Code: Infil Stain Continuous:  
 1st Dimension: 2nd Dimension: Percent: At/From: 7 To: ☐ Joint ☐ Step  
 Remarks:

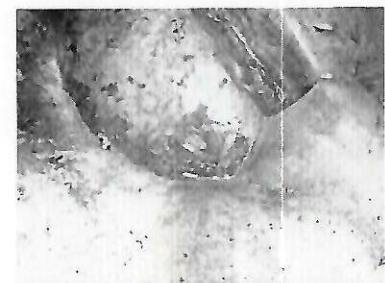
Distance 4.5 MH Component: Bench MACP Code: Deposits Settled Compacted Continuous:  
1st Dimension: 2nd Dimension: Percent: 5 At/From: 7 To: 5 ☐ Joint ☐ Step  
Remarks:
