## TOWN OF RIVER BEND

RE: Manhole Rehabilitation Project

## SANITARY SEWER MANHOLE INTERIOR REHABILITATION SPECIFICATIONS

## MACP Inspection Report

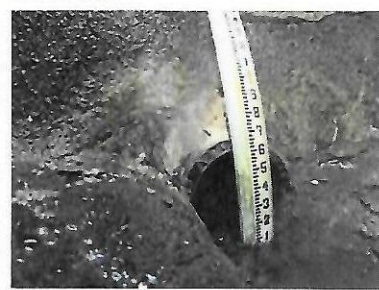
**Pipe #:** 2      **Clock:** 11      **Rim to Invert:** 6.9      **Direction:** In      **Material:** Reinforced Plastic Pipe (Truss Pipe)  
**Shape:** Circular      **Dia 1:** 8      **Dia 2:**      **Pipe Condition:** Sound  
**Seal Condition:** Defective      **Special Condition:** Gravity Relief Connection      **Pipe ID:** SGM-76  
**Comments:**

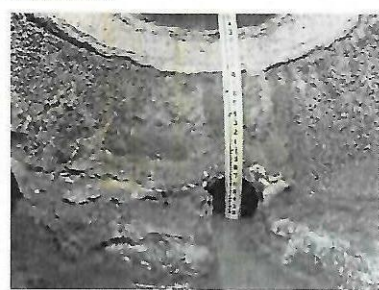
**Pipe #:** 3      **Clock:** 3      **Rim to Invert:** 6.7      **Direction:** In      **Material:** Reinforced Plastic Pipe (Truss Pipe)  
**Shape:** Circular      **Dia 1:** 8      **Dia 2:**      **Pipe Condition:** Sound  
**Seal Condition:** Sound      **Special Condition:** Gravity Relief Connection      **Pipe ID:** SGM-79  
**Comments:**

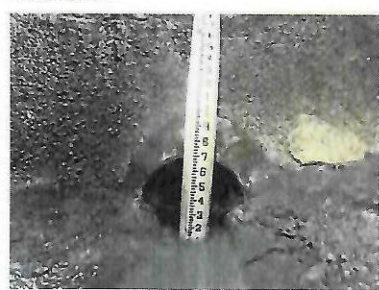
**Pipe #:** 1      **Clock:** 6      **Rim to Invert:** 7      **Direction:** Out      **Material:** Cast Iron  
**Shape:** Circular      **Dia 1:** 8      **Dia 2:**      **Pipe Condition:** Sound  
**Seal Condition:** Sound      **Special Condition:** Gravity Relief Connection      **Pipe ID:** SGM-80  
**Comments:**

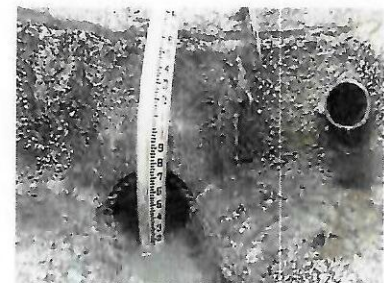
Pipe #: 1    Clock: 6    Rim to Invert: 5.4    Direction: Out    Material: Reinforced Plastic Pipe (Truss Pipe)  
 Shape: Circular    Dia 1: 8    Dia 2: 8    Pipe Condition: Sound  
 Seal Condition: Sound    Special Condition: Gravity Relief Connection    Pipe ID: SGM-79

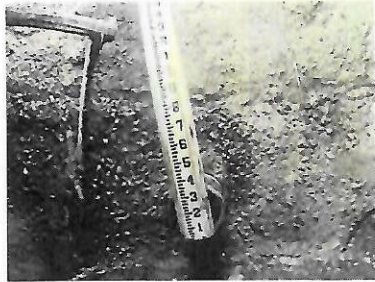
Pipe #: 2      Clock: 8      Rim to Invert: 4.5      Direction: In      Material: Polyvinyl Chloride  
Shape: Circular      Dia 1: 4      Dia 2      Pipe Condition: Sound  
Seal Condition: Sound      Special Condition: Lateral to Building      Pipe ID:  
Comments:

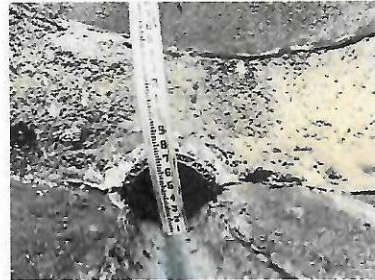
Pipe #: 3      Clock: 11      Rim to Invert: 5.2      Direction: In      Material: Reinforced Plastic Pipe (Truss Pipe)  
Shape: Circular      Dia 1: 8      Dia 2      Pipe Condition: Sound  
Seal Condition: Sound      Special Condition: Gravity Relief Connection      Pipe ID: SGM-77  
Comments:

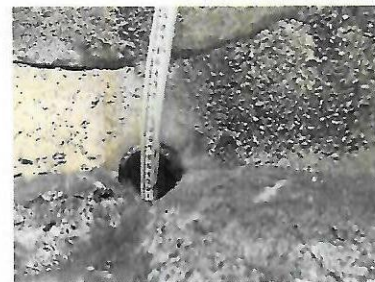
Pipe #: 4      Clock: 3      Rim to Invert: 5.2      Direction: In      Material: Reinforced Plastic Pipe (Truss Pipe)  
Shape: Circular      Dia 1: 8      Dia 2      Pipe Condition: Sound  
Seal Condition: Sound      Special Condition: Gravity Relief Connection      Pipe ID: SGM-78  
Comments:

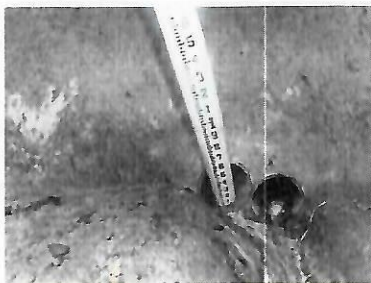
Pipe #: 2 Clock: 11 Rim to Invert: 4.8 Direction: In Material: Polyvinyl Chloride  
 Shape: Circular Dia 1: 6 Dia 2: Pipe Condition: Sound  
 Seal Condition: Sound Special Condition: Lateral to Building Pipe ID:

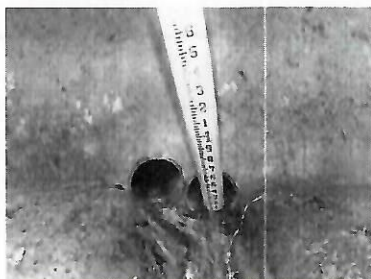
Pipe #: 3 Clock: 12 Rim to Invert: 4.7 Direction: In Material: Polyvinyl Chloride  
 Shape: Circular Dia 1: 6 Dia 2: Pipe Condition: Sound  
 Seal Condition: Sound Special Condition: Lateral to Building Pipe ID:

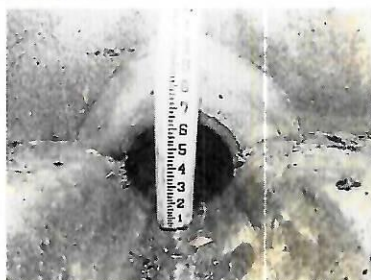
Pipe #: 1 Clock: 6 Rim to Invert: 5 Direction: Out Material: Reinforced Plastic Pipe (Truss Pipe)  
 Shape: Circular Dia 1: 8 Dia 2: Pipe Condition: Sound  
 Seal Condition: Sound Special Condition: Gravity Relief Connection Pipe ID: SGM-78
